Recreation Enhancement of the Lamprey River Between Route 87 and Wadleigh Falls

Final Report to the Lamprey River Wild and Scenic 2015 Small Grants Program

Recreation Enhancement of the Lamprey River between Route 87 and Wadleigh Falls

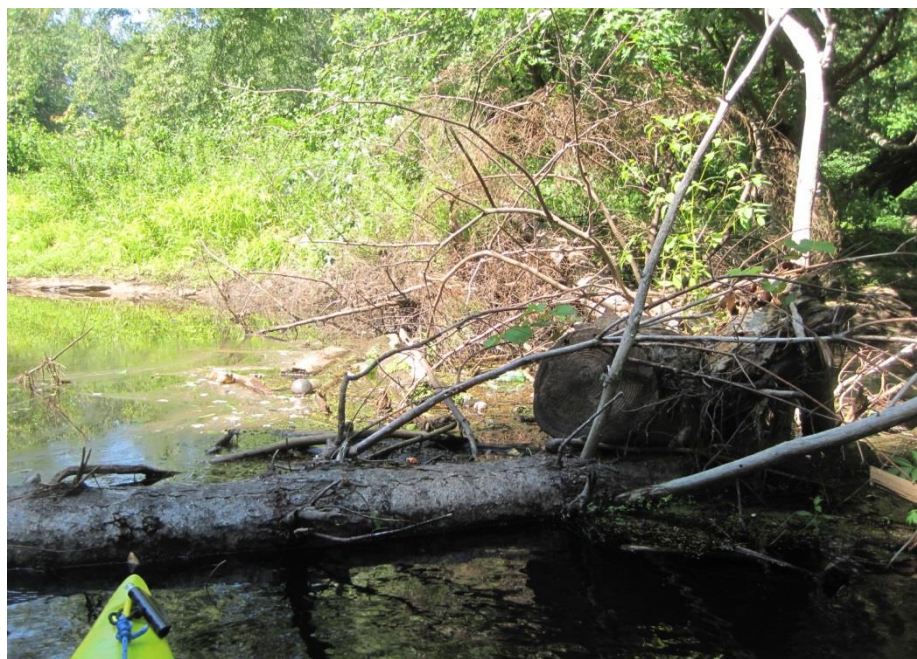
Trash can accumulate behind log jams and act as a screen. Until higher water flushes the trash away, the back waters are often cluttered with plastics and other junk.

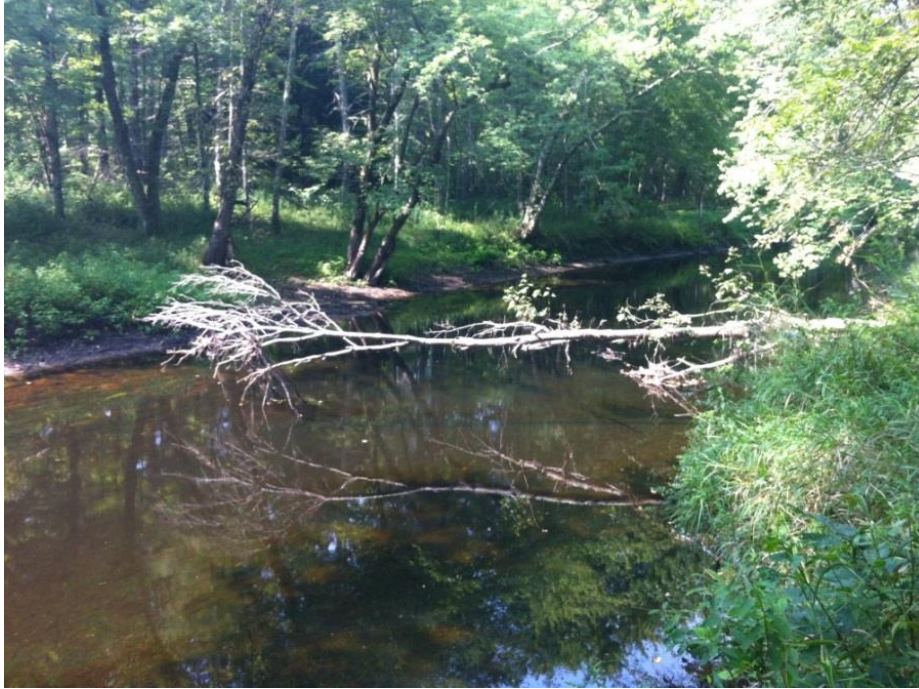
Some of the downed trees and woody debris was small or minor and could easily be navigated around. In the photo to the left, the branch is small and does not extend completely from one bank to the other. Any paddler can steer to the left and brush past the flexible branch ends and continue on their paddle without having to encounter any danger or portage.

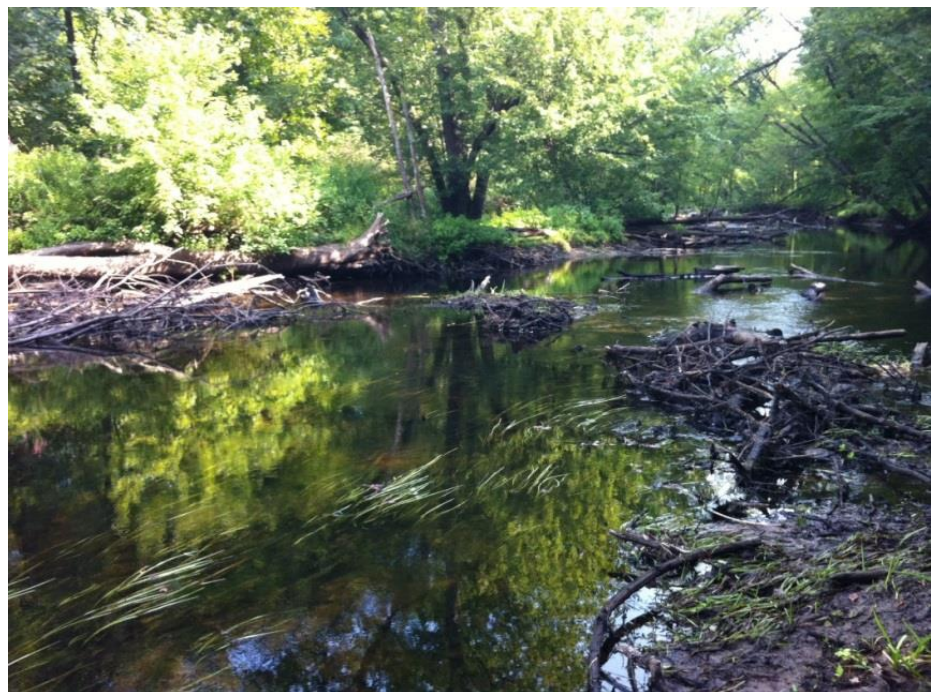
At other locations, debris in the river was low and more or less anchored to the bed of the river and passage by boat could occur by over the low debris. In addition, because the placement of the debris is on the sides of the channel the recreational paddler can meander through with little hazard or difficulty.

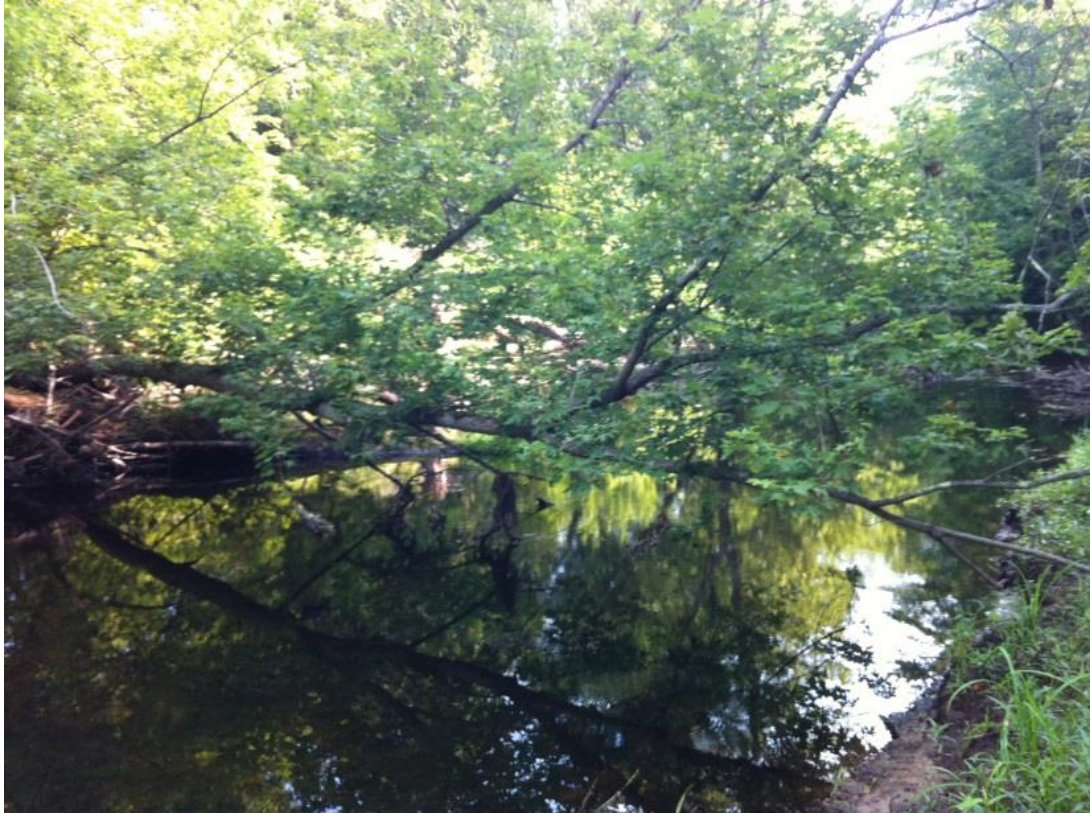
Downed trees that are above the water level may or may not be a hazard depending on the water level. Because the tree in the photo below is bank to bank it could be a hazard if the height of the water is within three feet of the branch. The amount of live branches above would prohibit being able to pass over the horizontal branch. Portage would be required unless the water level is low enough to allow the paddler to safely pass under.

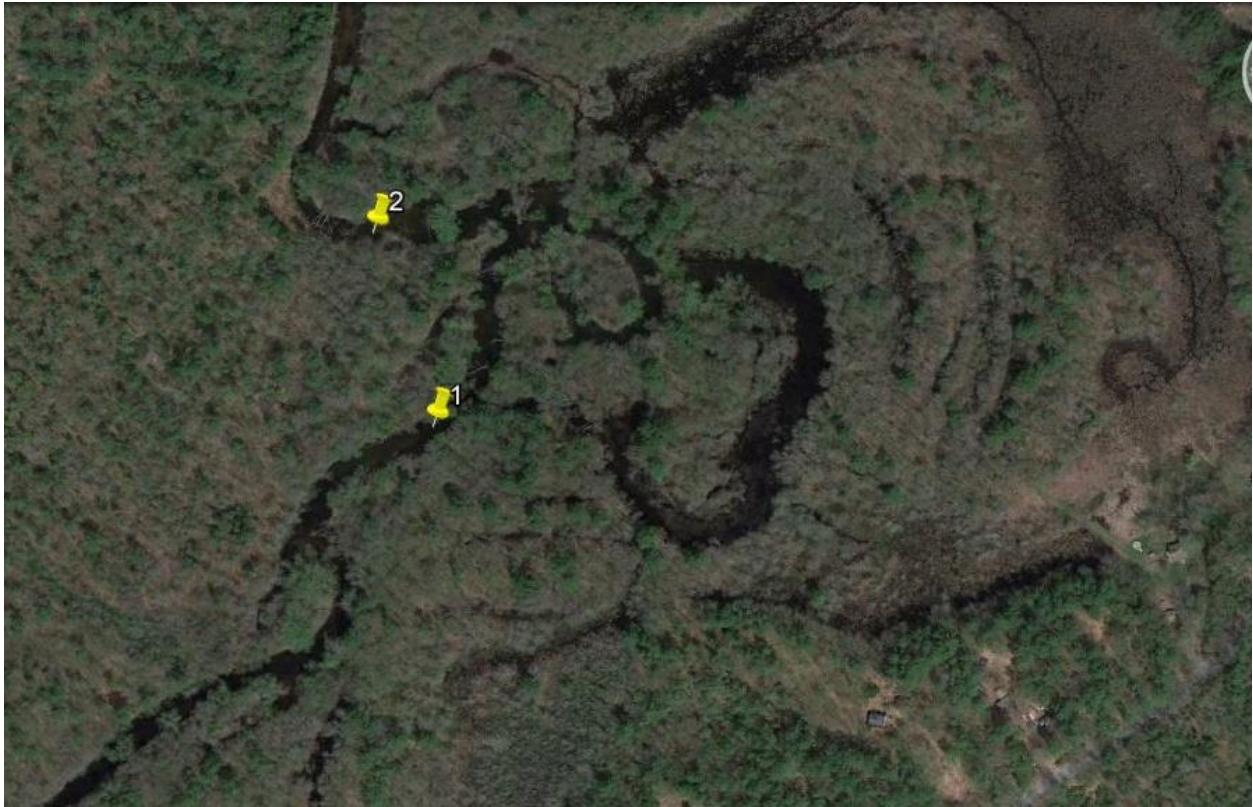
Sites 1 and 2

Site 1 is located approximately a mile and a quarter downstream from the Route 87 bridge with two blockages about 100 feet apart. The bank is about three feet high and the portage required is about 200 feet.

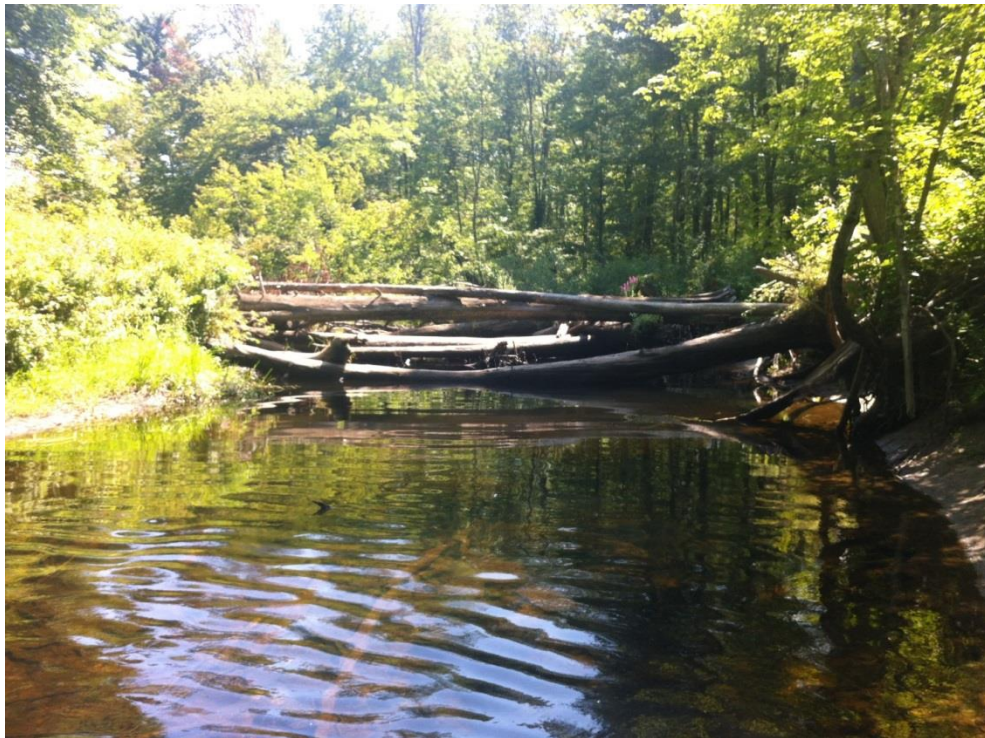
Site 2 is just a bit beyond and is a mass of more than ten trees. This area of the river is densely wooded floodplain with old oxbows, remnant channels and vernal pools. The river has changed channels many, many times over a long period of time. Portage is about 150 feet.

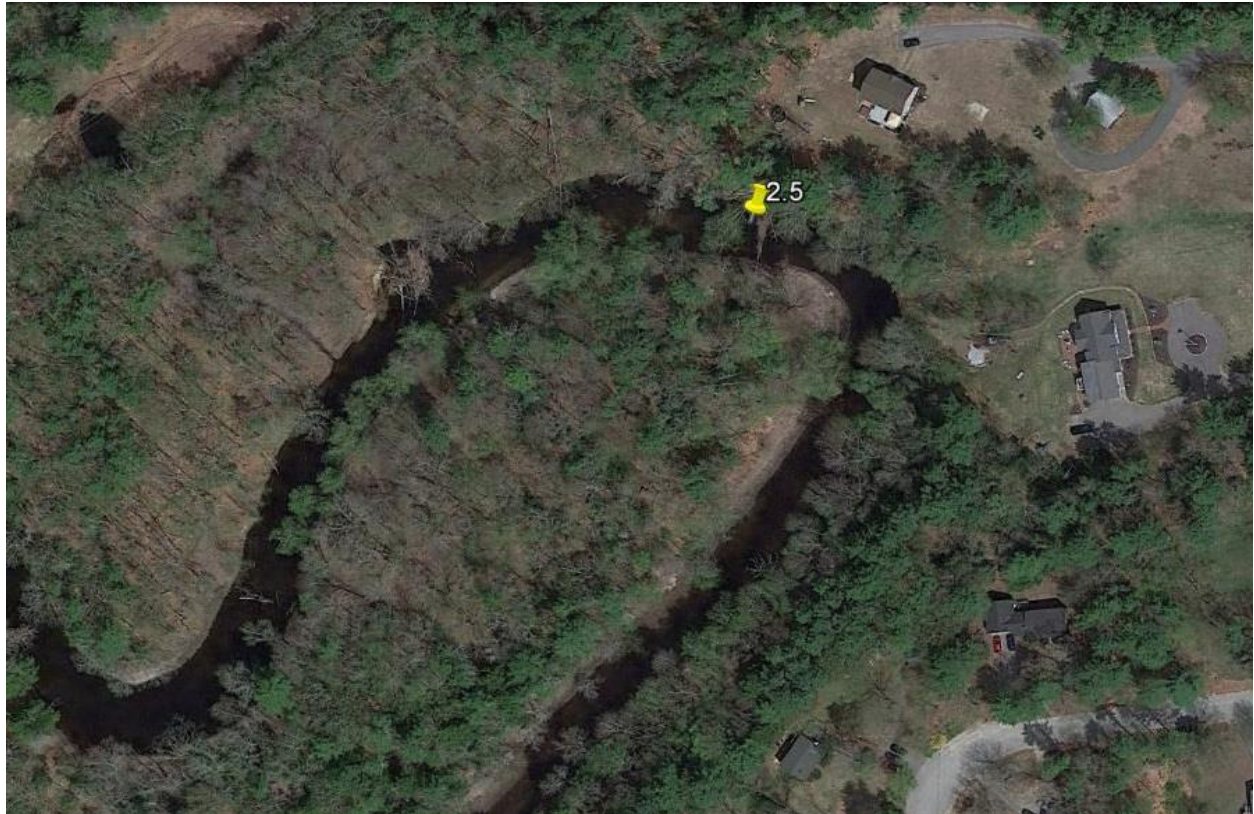
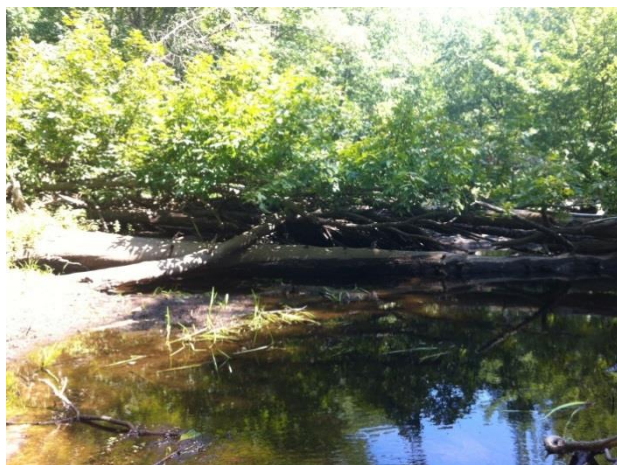
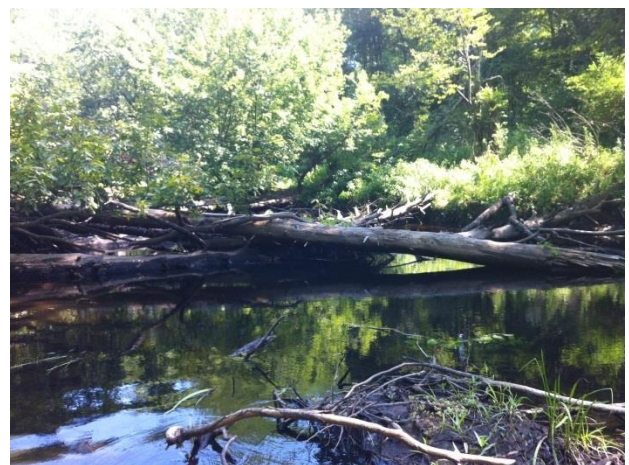
Site 2.5 is located approximately two miles downstream from the Route 87 bridge. It is a mass of large trees that are blocking the entire river from bank to bank. The jam is several logs deep in width with some tree tops still alive and growing. On the back side of the jam are piles of smaller limb debris making this a significant blockage in width, length and depth. A paddler must portage around this obstruction and the best bet is on the left bank.

This multiple tree blockage extends from bank to bank with many complex tangles. At no time is it ever safe to try to get over this jam without exiting your boat. Shortest carry is to the left.

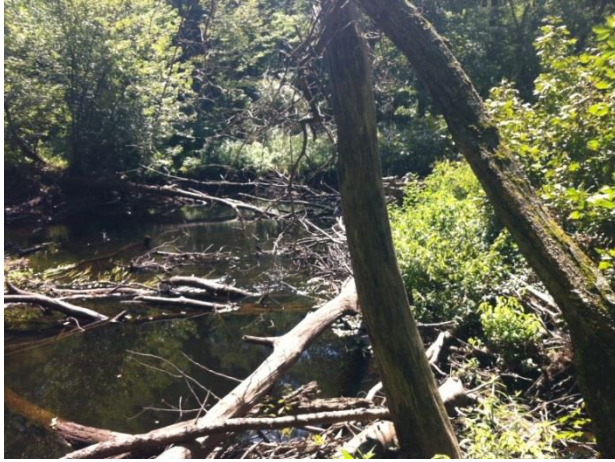
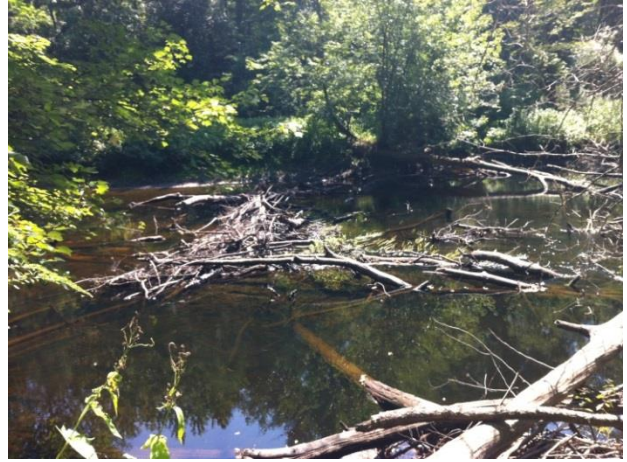
The back side of Site 2.5 is just as tangled and hazardous.

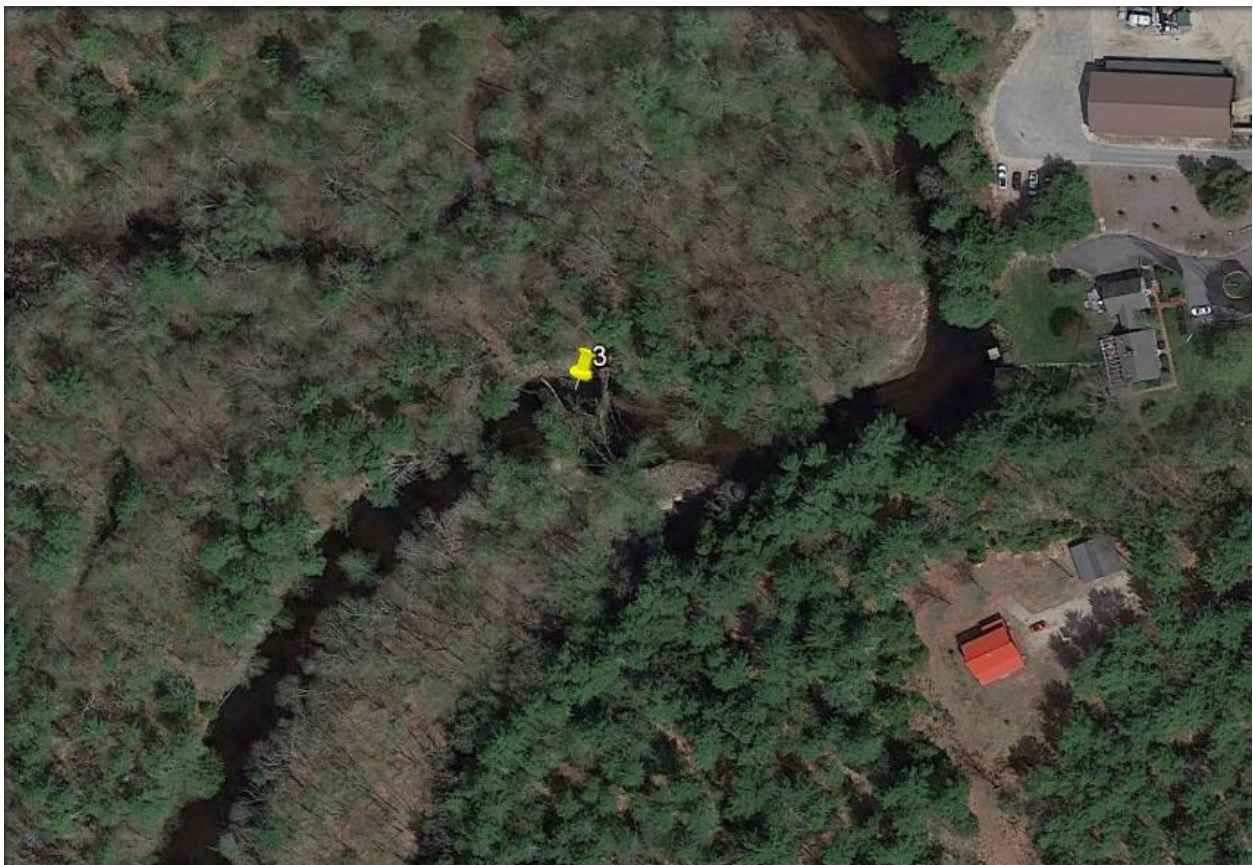
Site 3

About two and three quarters of a mile into the trip, a paddler will encounter Site 3. This is another blockage spanning the channel from bank to bank and consisting of more than ten trees. A short portage on the right is required.

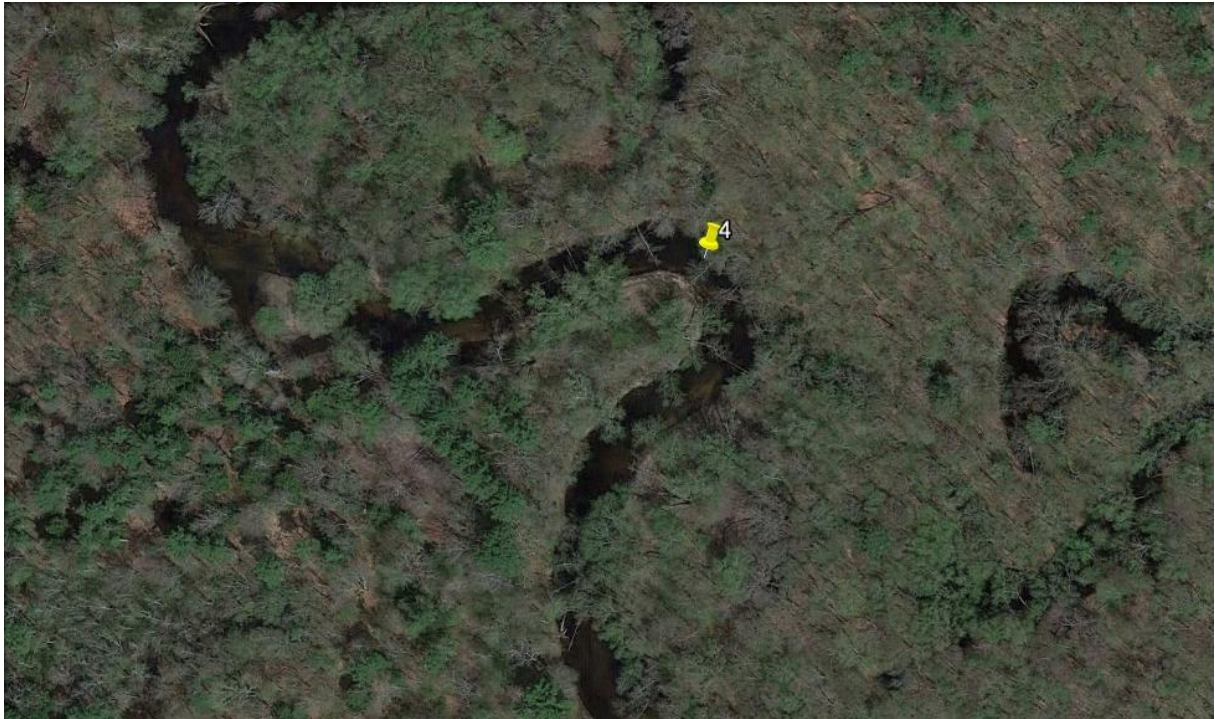
Site 4

This site is one that was present in the reconnaissance trip of 2014 but not in 2015. The logs had moved downstream. In 2014, a 50 foot portage to the left was recommended. In 2015, the blockage was no longer present.

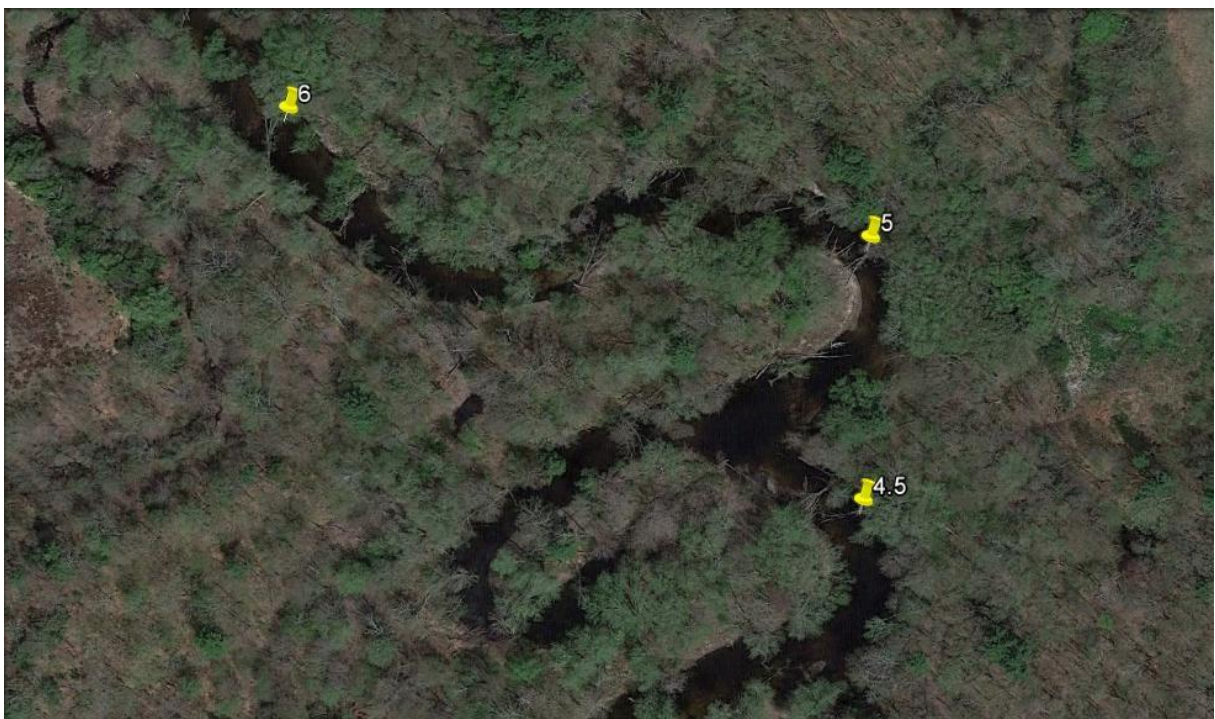
Sites 4.5, 5 and 6

Three major blockages exist just over three miles into the trip. In a series of deep river bends, each bend creates an opportunity for the water to slow down, for trees being washed downstream to catch on the banks of the bend in the river and begin to pile up.

Site 4.5 is a blockage of greater than ten large trees. About a 300 foot portage is required on the river right to get past this large blockage. On the next oxbow is Site 5 which is a double blockage and portage to the left for about 500 feet is required. This area also has extensive amounts of poison ivy as the major ground cover so boaters are sure to be extra annoyed and the terrain if not already put out by the hefty portage. Site 6 can be gotten past by heaving the boat behind a root wad on the left side of the river and may even be possible in higher water. Again, slippery, muddy banks and poison ivy abound.

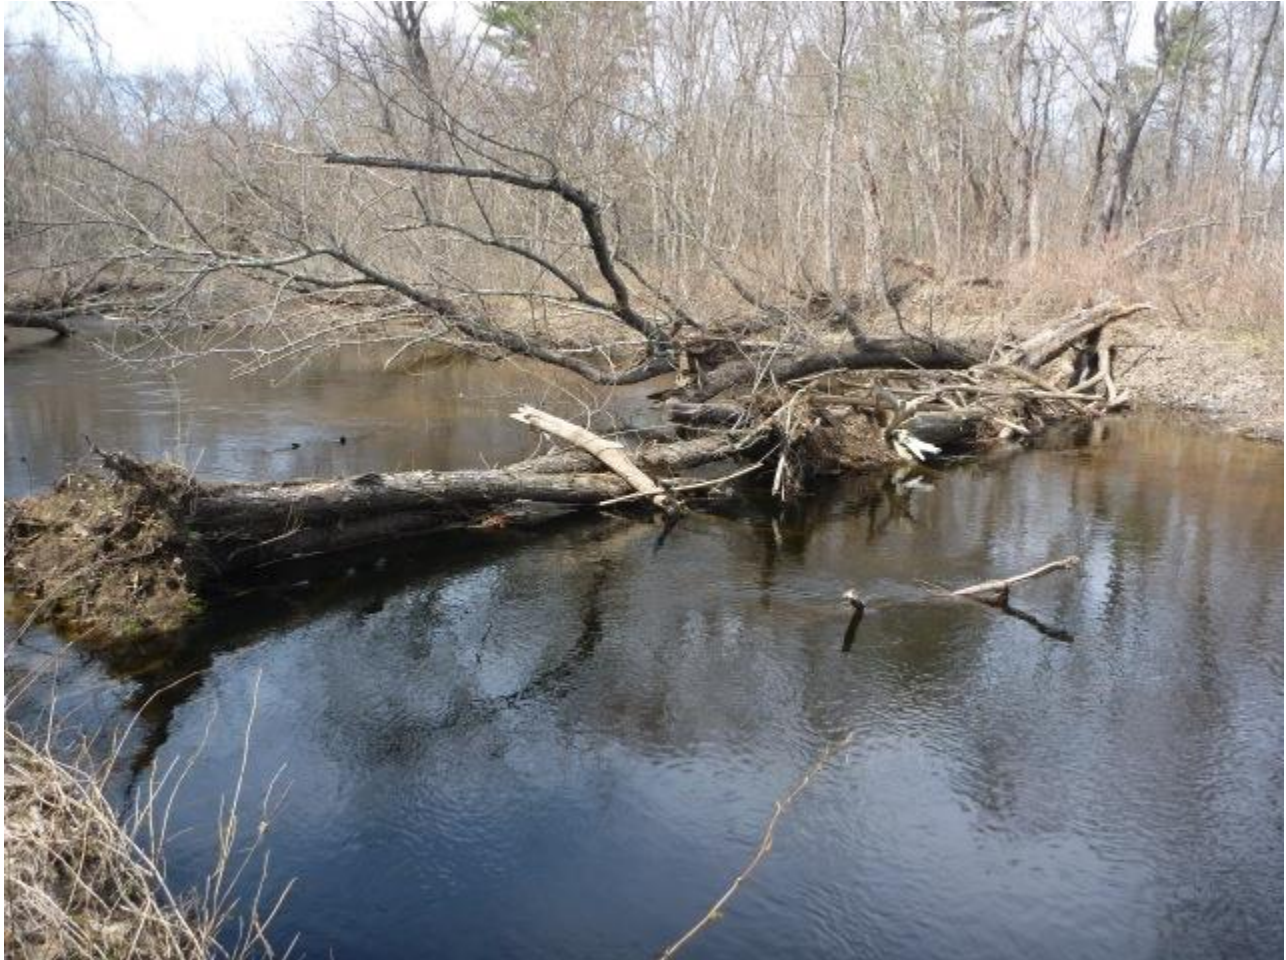
Above: Site 6 where passage is possible around the left end of the tree depending on water depth.
