APPENDIX A. Fish Survey Summary by Subwatershed

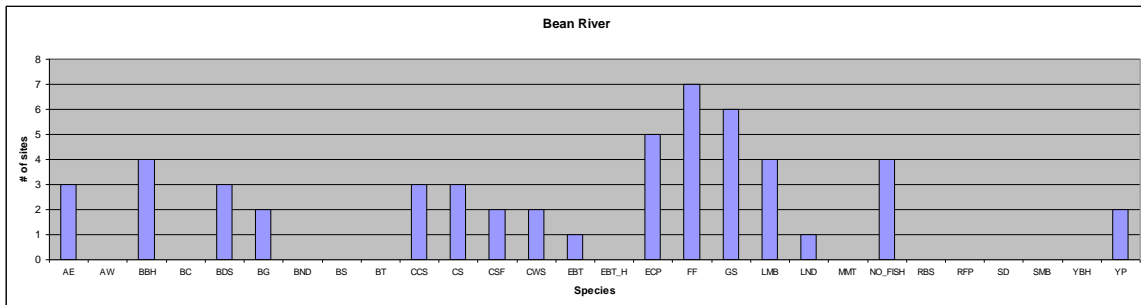
Figure A.1 - Number of species recorded at 16 sites surveyed in the Bean River subwatershed.

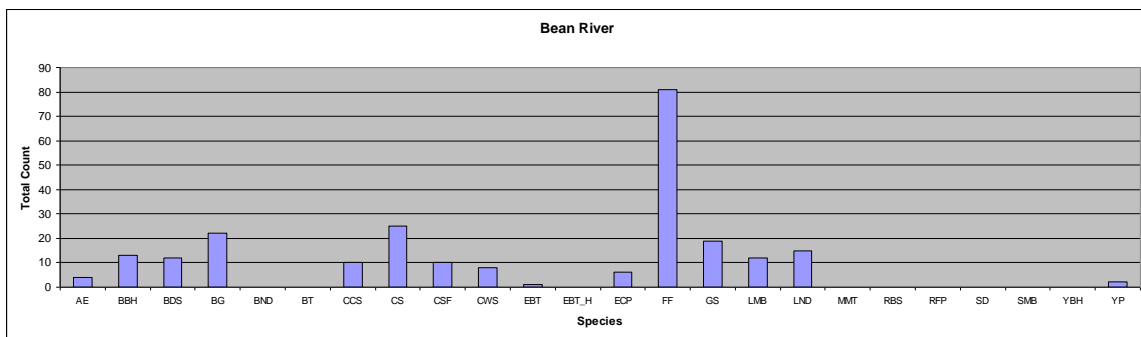
Figure A.2 - Total counts of each species captured at 16 sites in the Bean River subwatershed.

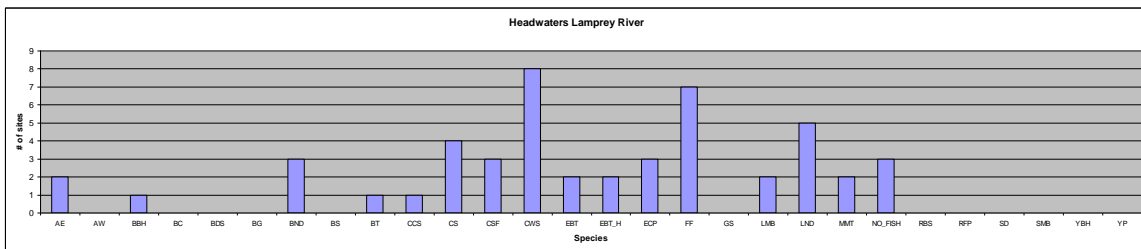
Figure A.4 - Number of species recorded at 16 sites surveyed in the Lamprey River Headwaters subwatershed.

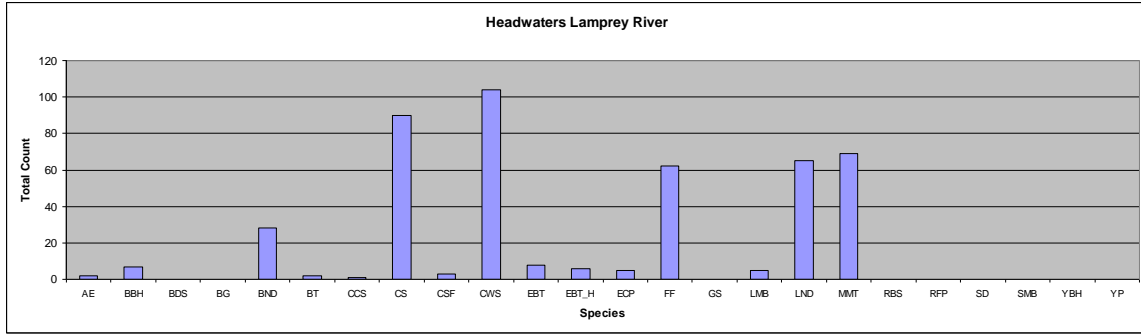
Figure A.5 - Total counts of each species captured at 16 sites in the Lamprey River Headwaters subwatershed.

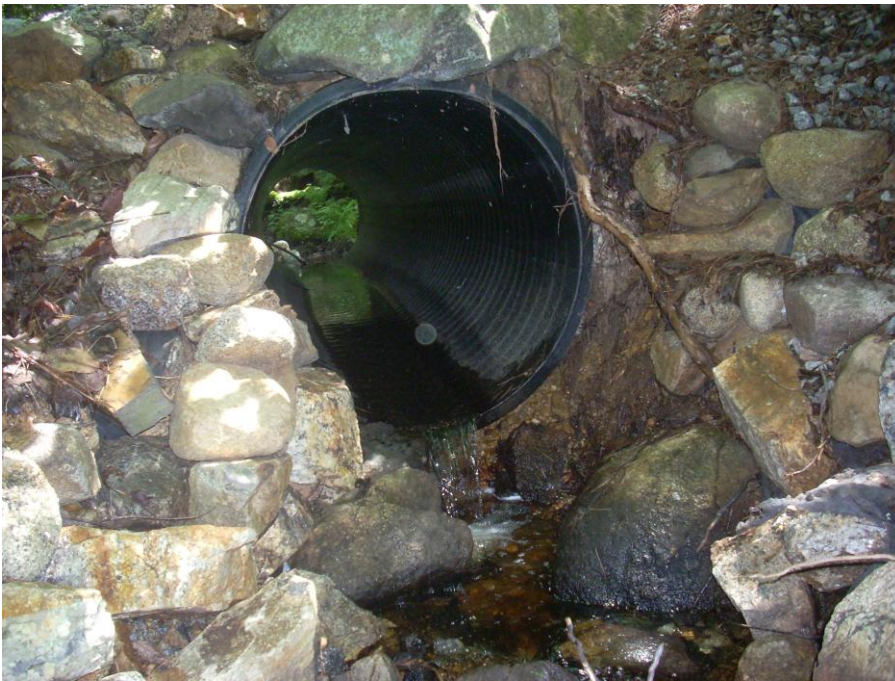
Figure A.6 - One of three driveway culverts impacting fish passage on a coldwater stream in the Lamprey River Headwaters subwatershed.

The Lamprey River Headwaters subwatershed has an estimated 81 stream crossings. The cumulative effects of these stream crossings, many of which were washed out multiple times during floods over the past 6 years, might have contributed to the excessive sediment deposition that has contributed to declines in freshwater mussels downstream (Nedeau 2011). A stream crossing inventory that documents and prioritizes stream crossings in need of restoration would be beneficial in this subwatershed.

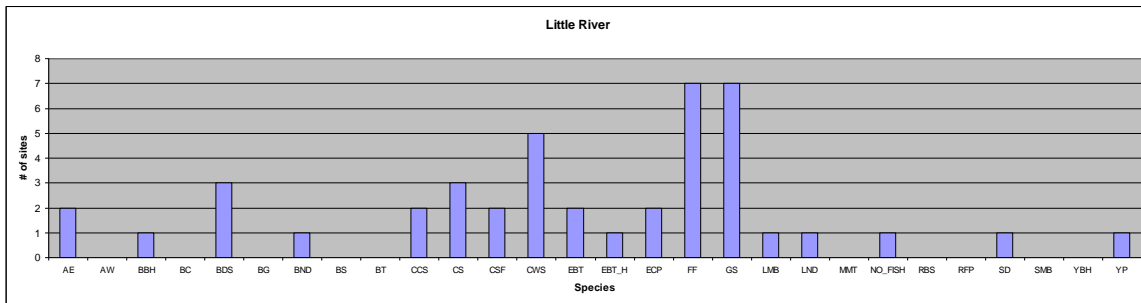
Figure A.8 - Number of species recorded at 11 sites surveyed in the Little River subwatershed.

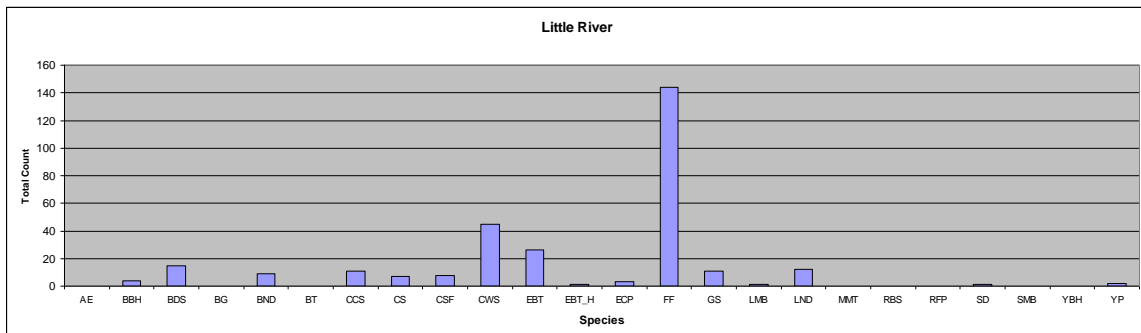
Figure A.9 - Total counts of each species captured at 11 sites in the Little River subwatershed.

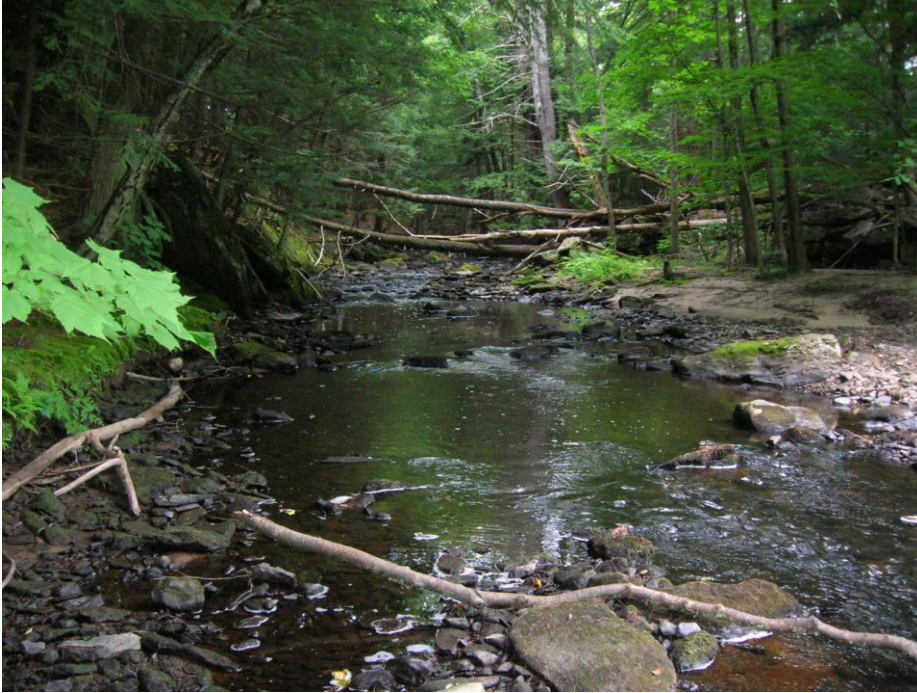
Figure A.10 - A typical reach of the Little River, with its wide channel, broad floodplains, and sandy substrate mixed with gravel and cobble.

Habitat in the Little River is generally a meandering stream channel surrounded by broad floodplains with sand, gravel, and cobble substrate. Two significant dams are found in the watershed, one at Nottingham Lake and another at Mendum's Pond. These dams are barriers to upstream fish migration. Both dams might be good candidates for eel passage. While eels have been documented in Mendum's Pond, these dams probably reduce the eel population in the headwaters of the Little River. These dams might also be contributing to warmer temperatures in the Little River.

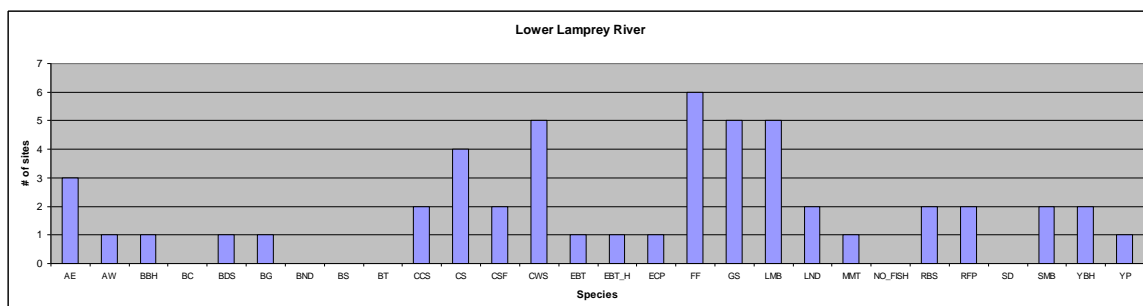
Figure A.11 - Number of species recorded at 11 sites surveyed in the Lower Lamprey River subwatershed.

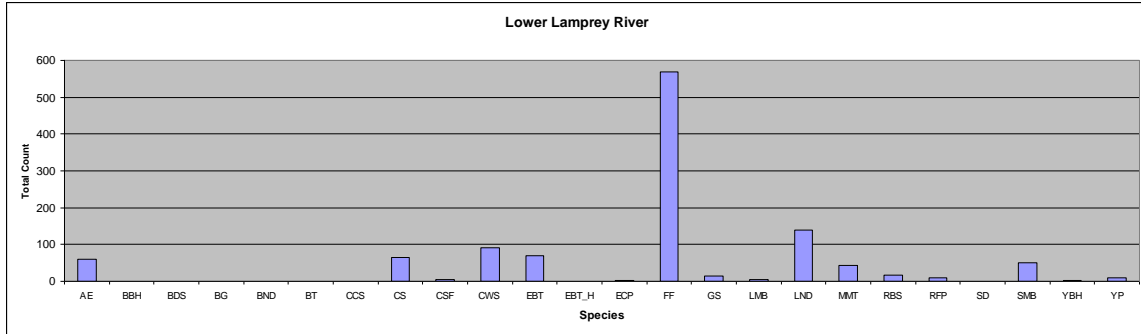
Figure A.12 - Total counts of each species captured at 11 sites in the Lower Lamprey River subwatershed.

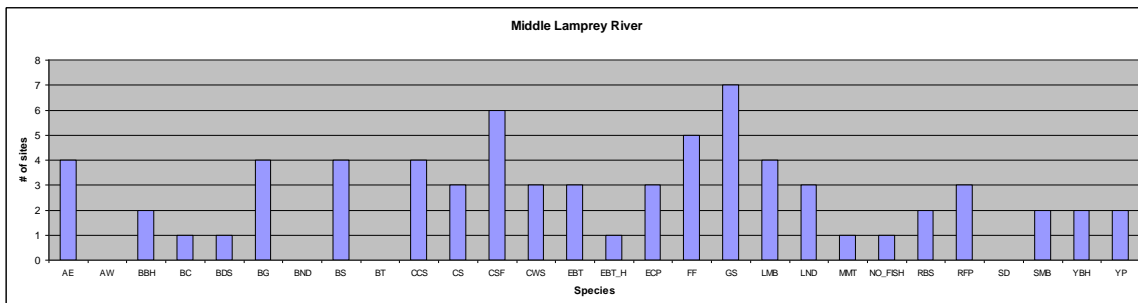
Figure A.14 - Number of species recorded at 14 sites surveyed in the Middle Lamprey River subwatershed.

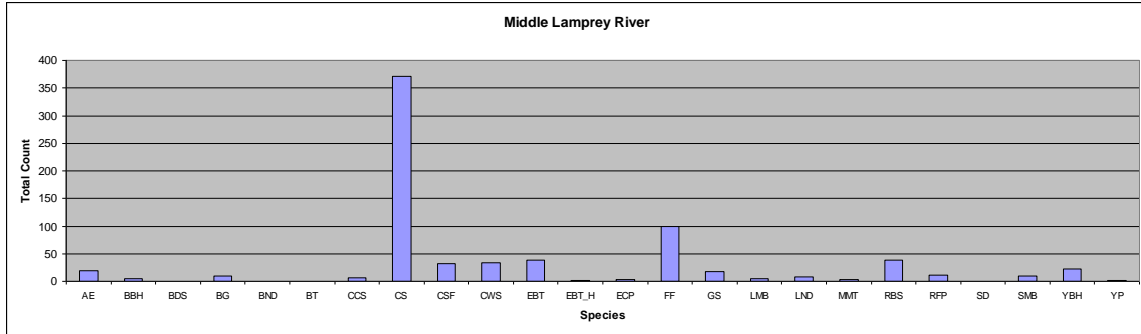
Figure A.15 - Total counts of each species captured at 14 sites in the Middle Lamprey River subwatershed.

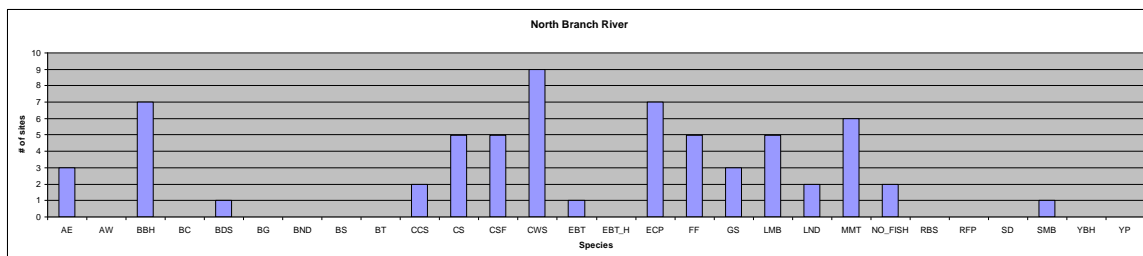
Figure A.17 - Number of species recorded at 15 sites surveyed in the North Branch River subwatershed.

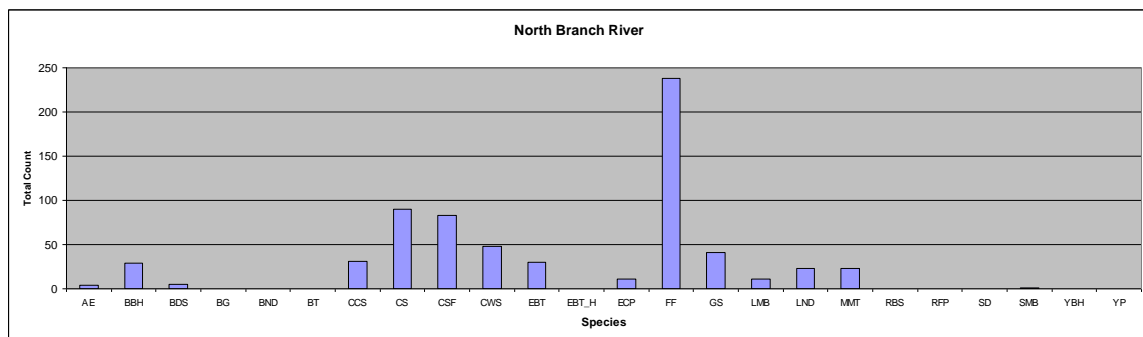
Figure A.18 - Total counts of each species captured at 15 sites in the North Branch River subwatershed.

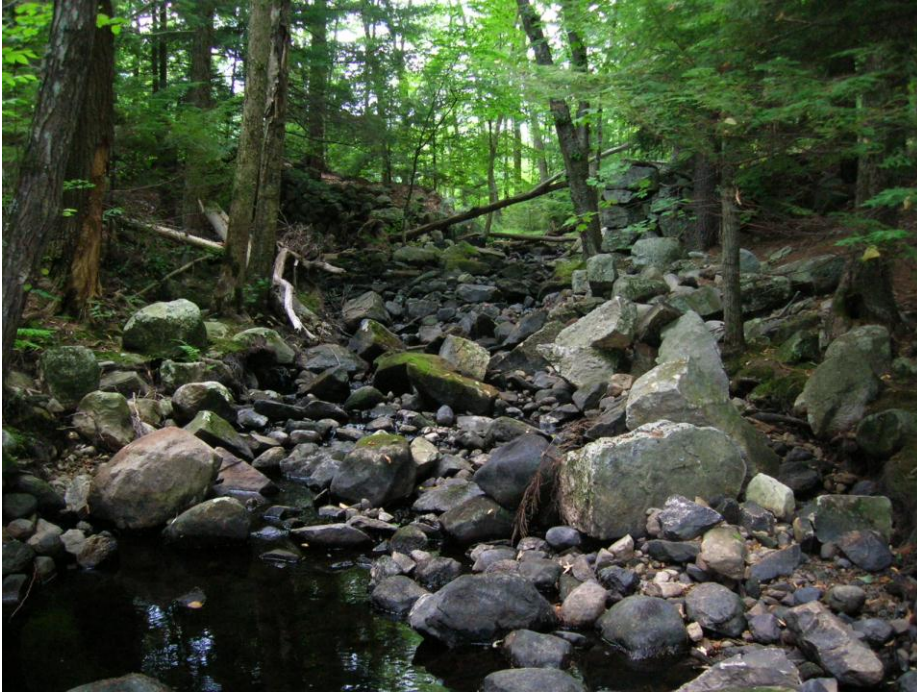
Figure A.19 - Rocky stream channel downstream from the ruins of an old mill.

The headwaters of the North Branch River provide some of the best examples of old mill structures at the transition between low gradient wetland streams or beaver ponds and steeper rocky streams below the ruins of an old dam or road (Fig. A.19). This pattern is reflected in the fish survey data, with a number of species, such as brown bullhead, common sunfish, and chain pickerel that were captured in higher gradient, rocky stream sections below old mill dams. These species are usually associated with wetland streams or pond habitat.

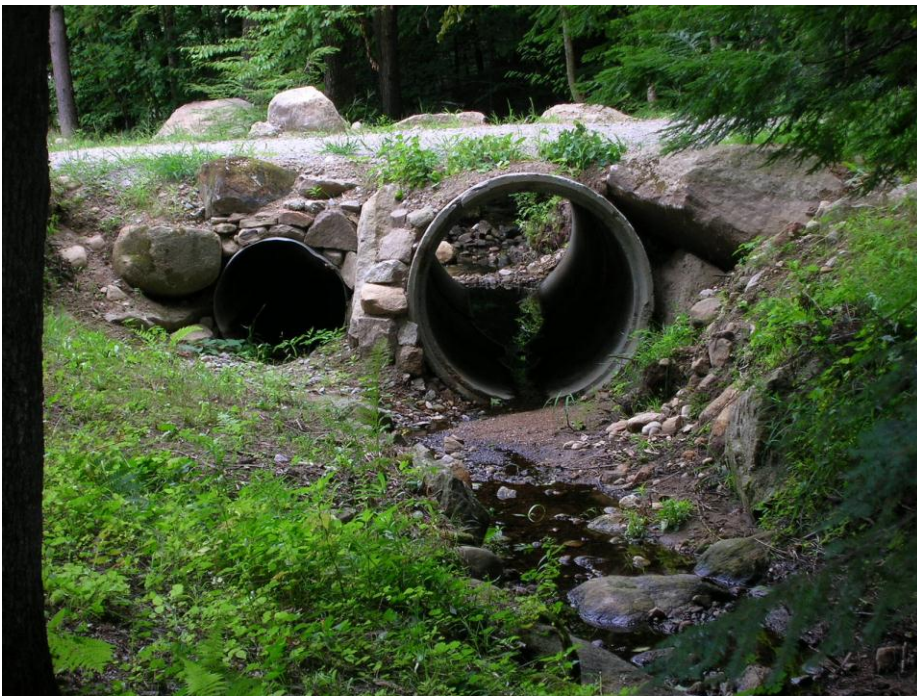
Figure A.20 - This driveway culvert marks the downstream limit of brook trout in Aunt Mary Brook.

Seventeen temperature sensors were deployed throughout the North Branch River subwatershed in 2007. The average water temperature in July and August was above the threshold (19°C) for supporting wild brook trout at all sites except for one cold water stream known locally as Aunt Mary Brook. The stream, which flows north into the North Branch River near its confluence with the Lamprey River in east Candia, likely receives groundwater from the valley fill aquifers deposited in this region (Moore 1990). The lower section of Aunt Mary Brook was filled with sediment and had run dry due to the impacts of a driveway culvert and the excavation of the streambed near a residence (Fig. A.20). Thirty wild brook trout were captured above the culvert. Replacing the culvert with a properly sized crossing and restoring the stream channel downstream would greatly increase the amount of habitat available to brook trout as well as restore the connection between Aunt Mary Brook and the North Branch River.

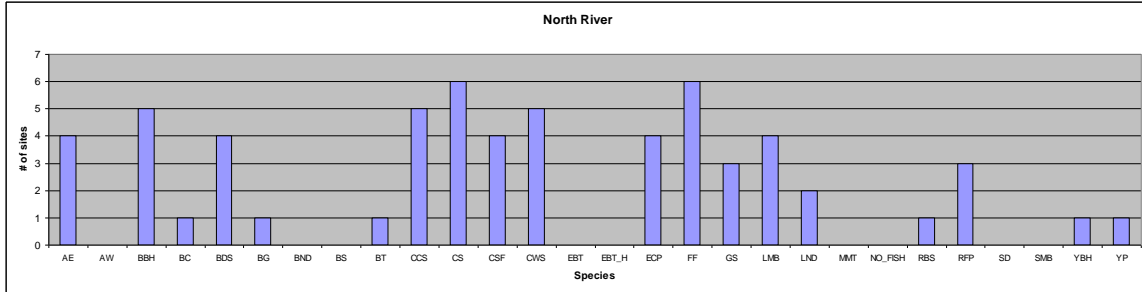
Figure A.21 - Number of species recorded at 9 sites surveyed in the North River subwatershed.

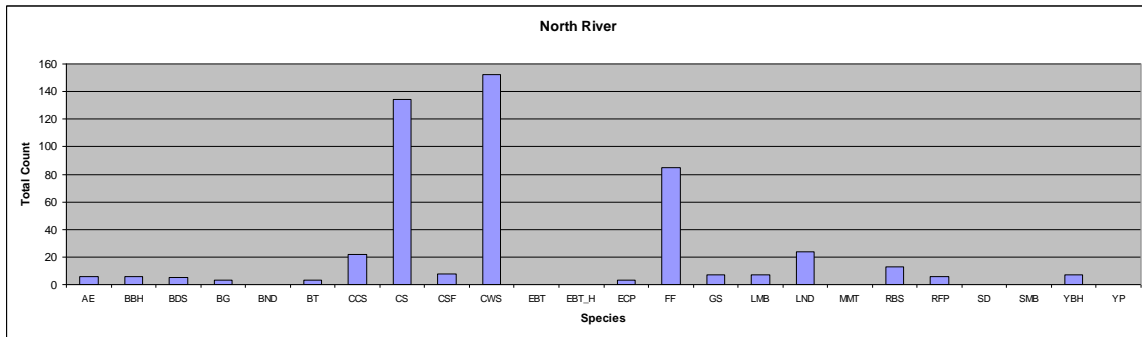
Figure A.22 Total counts of each species captured at 9 sites in the North River subwatershed.

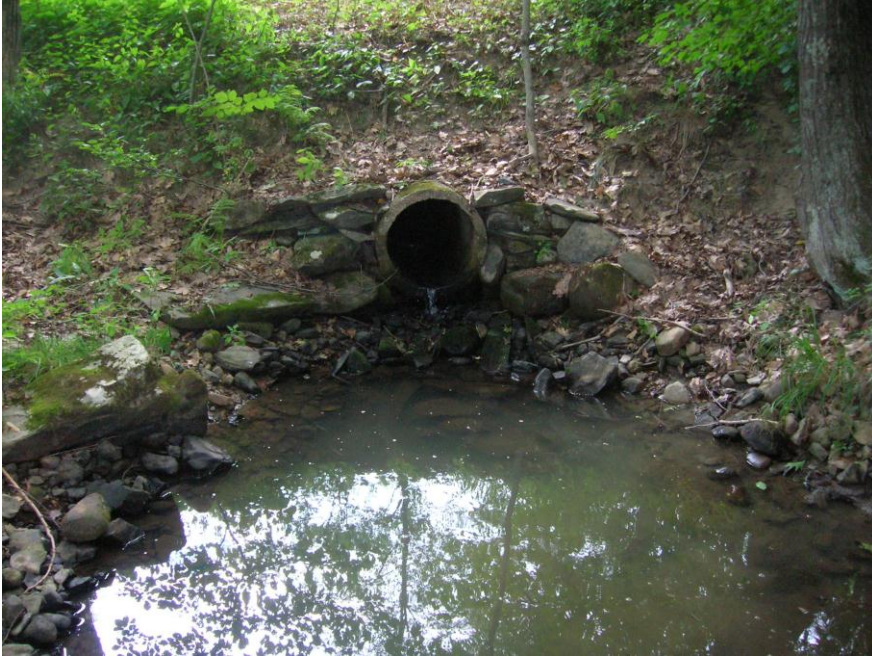
Figure A.24 - Perched culvert above scour pool where brook trout were captured in an unnamed tributary of the lower North River.

Wild brook trout were found in one small tributary of the North River downstream of Birch Hill Road in Lee. Most of the trout were found in a small pool below a perched culvert, but two juvenile brook trout were found upstream of Birch Hill Road (Fig. A.24). Additional surveys should be conducted to determine the viability of this brook trout population. If suitable habitat exists for a significant length of the stream, then the perched stream crossing might be a candidate for replacement.

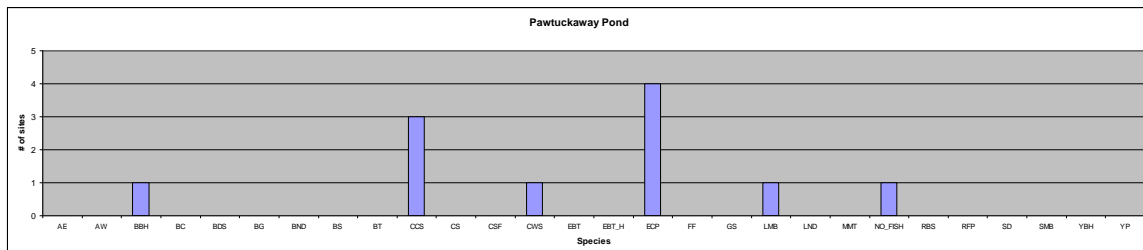
Figure A.26 - Number of species recorded at 6 sites surveyed in the Pawtuckaway Pond subwatershed.

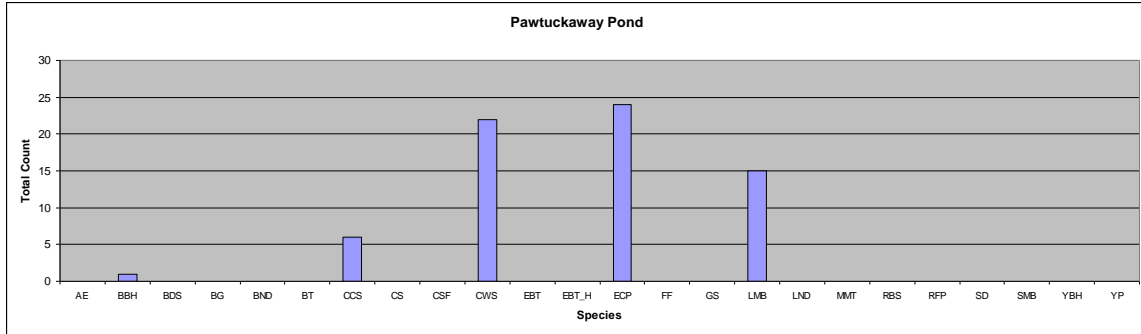
Figure A.27 - Total counts of each species captured at 6 sites in the Pawtuckaway Pond subwatershed.

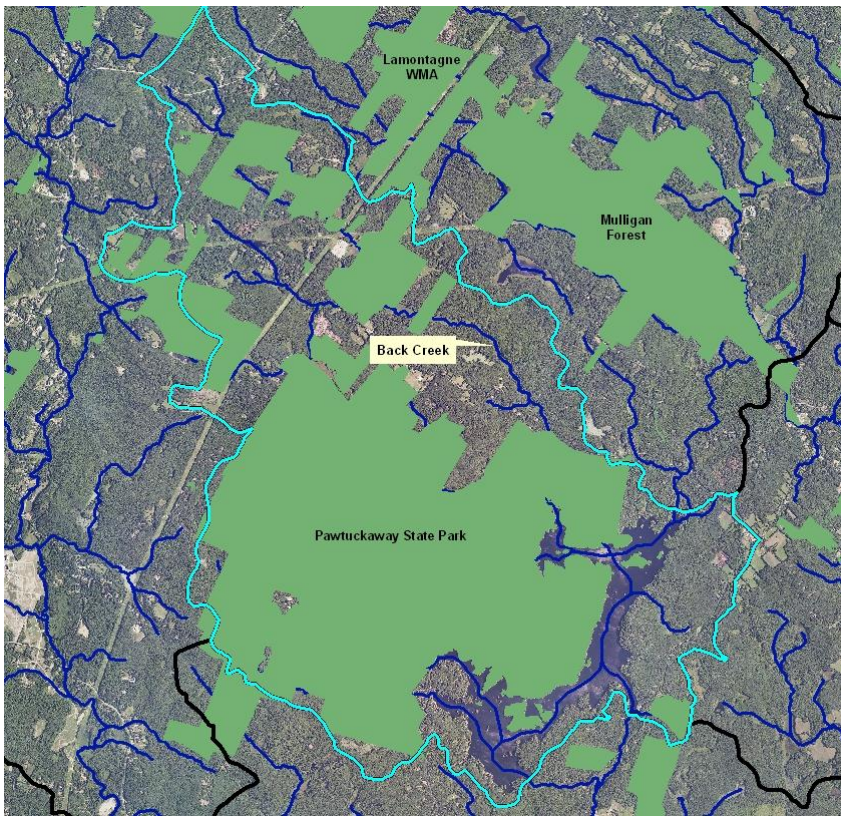
Figure A.28 - Protected land (green) in the Pawtuckaway Pond subwatershed.

Most of the Pawtuckaway Pond subwatershed is protected by Pawtuckaway State Park. It is the only subwatershed in the Lamprey River drainage that did not see a significant increase in impervious surface coverage between 1990 (2.7%) and 2010 (5.2%). The Pawtuckaway Pond subwatershed also contains the lowest estimated number of stream crossings (31). Conservation work in this subwatershed should focus on protecting the patchwork of conservation lands around the Lamontagne Wildlife Management Area to the north and the Back Creek watershed, which would link Pawtuckaway State Park with the Mulligan Forest conservation easement (Fig. A.28). This would expand one of the largest blocks of unfragmented forest in southeastern New Hampshire, benefitting water quality, aquatic species, and terrestrial species that require large territories (such as bobcats and black bears). This is also a critical subwatershed for maintaining summer flows in the lower Lamprey River, which might be supplemented with water from Pawtuckaway Pond during drought conditions (NHDES 2011).

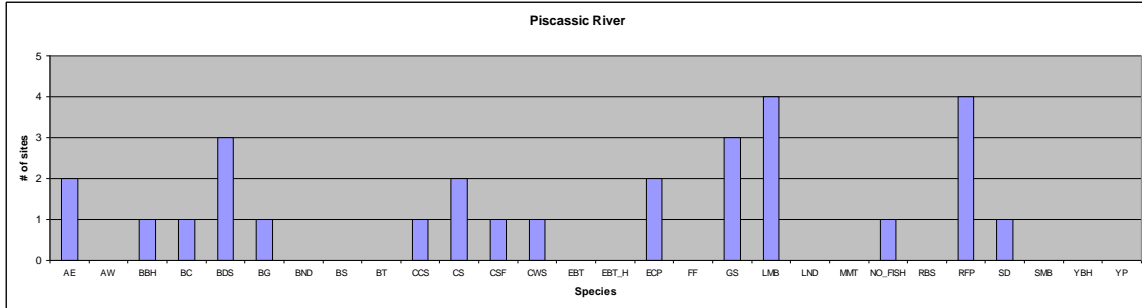
Figure A.29 - Number of species recorded at 7 sites surveyed in the Piscassic River subwatershed.

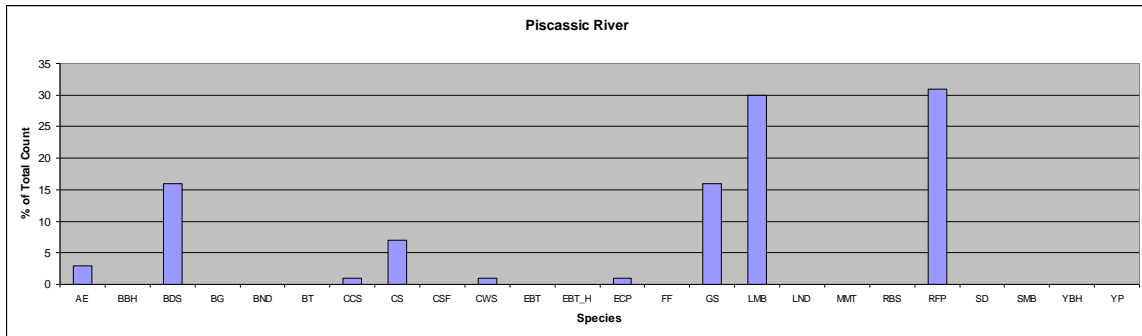
Figure A.30 - Total counts of each species captured at 7 sites in the Piscassic River subwatershed.

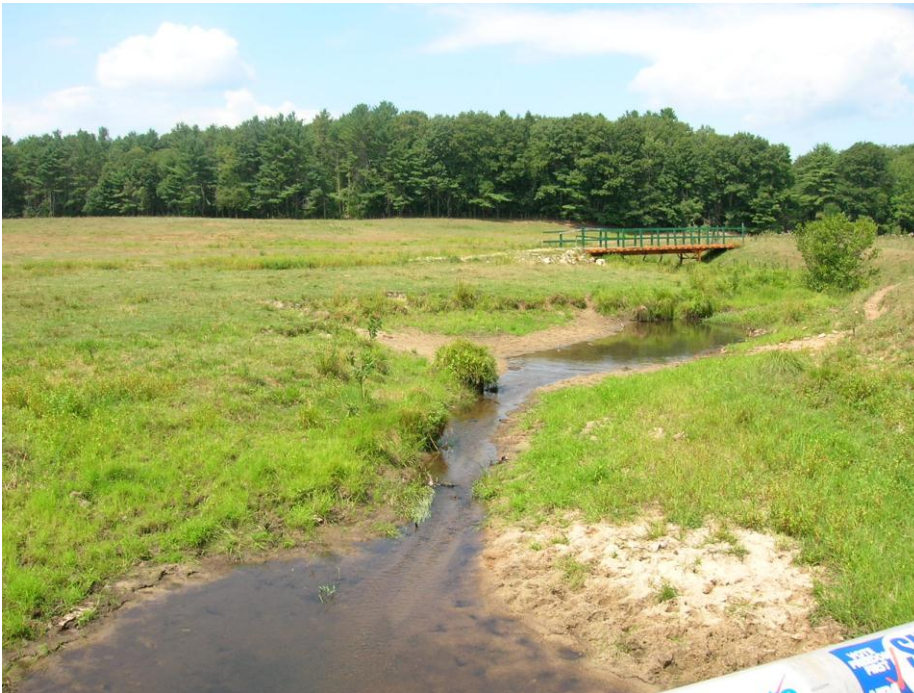
Figure A.31 - Livestock grazing in riparian zones can lead to severe stream bank erosion.

While the river itself is largely intact, the tributaries show signs of impacts from expanding development. Perched culverts, bank erosion, and stormwater runoff impacts were observed at multiple sites. Impervious surfaces increased from 9.6% in 1990 to 19.7% of the subwatershed area in 2010. Although undersized stream crossings were the most common impact in the Piscassic River subwatershed, at least one site demonstrated the severe damage that certain agricultural practices can cause to stream habitat (Fig. A.31). Improving stormwater management, stream crossing design, and riparian zone protection on the tributaries of the Piscassic River will help protect water quality and aquatic habitat in the mainstem.
