Recreation Enhancement of the Lamprey River Between Route 87 and Wadleigh Falls

Final Report to the Lamprey River Wild and Scenic 2015 Small Grants Program

Recreation Enhancement of the Lamprey River between Route 87 and Wadleigh Falls

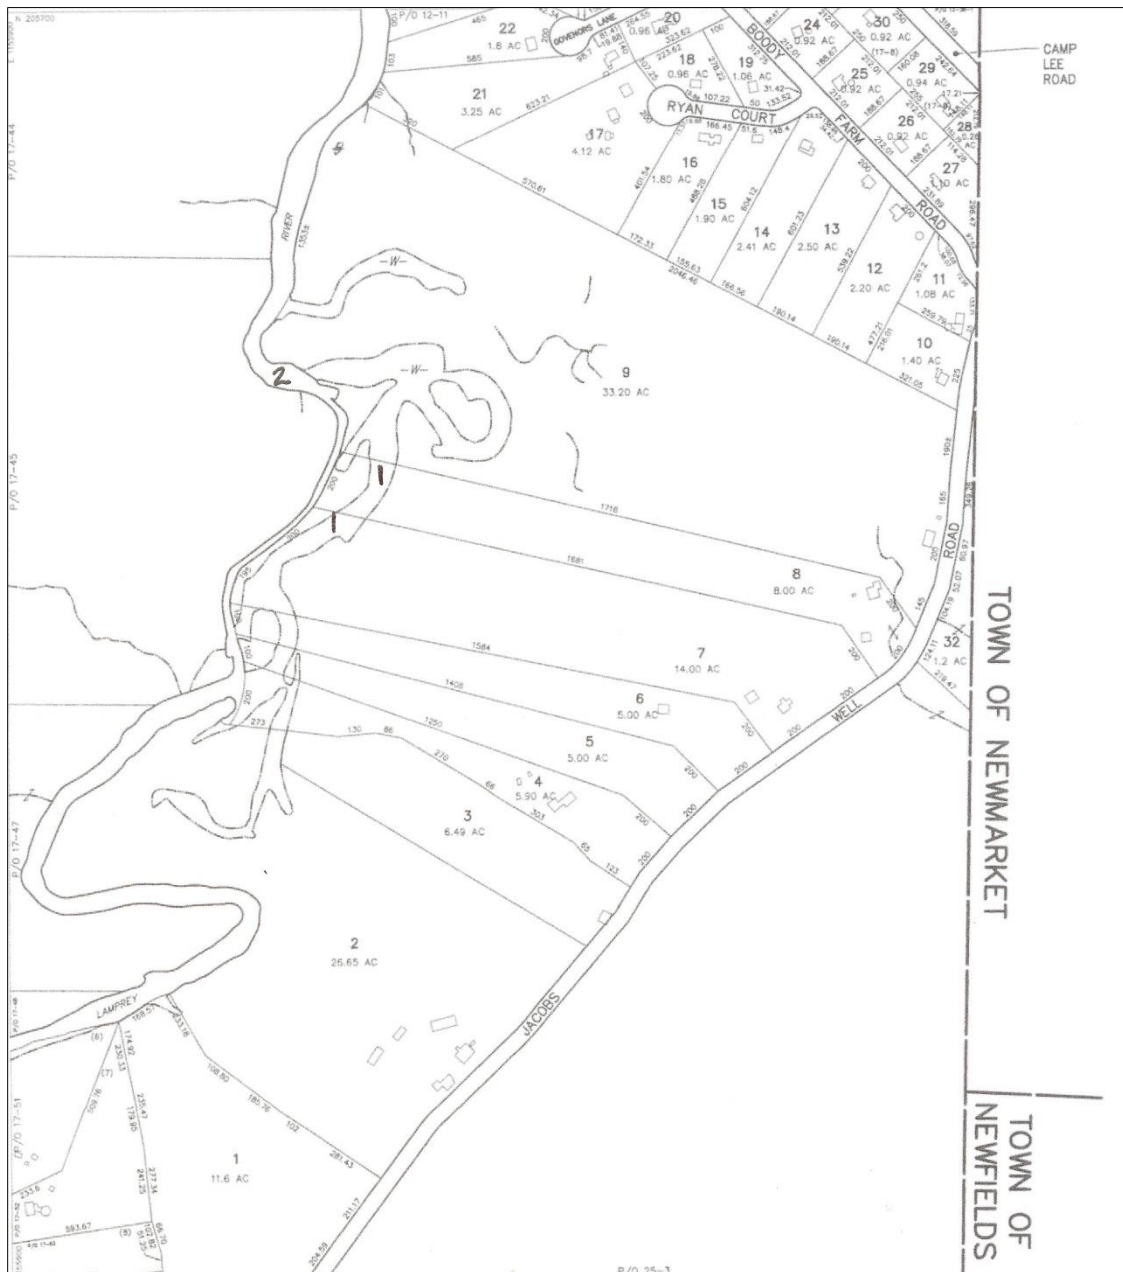
Blockage Site #	Map #	Lot #	Acres	Side of River	Landowner
1	18	7	14	East	Paul Richards, 100 Jacobs Well Road, Epping
1	18	8	8	East	Walter Bilynsky, 104 Jacobs Well Road, Epping
2	17	45	75	West	Candace Thayer, 175 Cabot St Unit #1, Portsmouth
2	18	9	33.2	East	David & Jackie Edgerly, 112 Jacobs Well Road, Epping

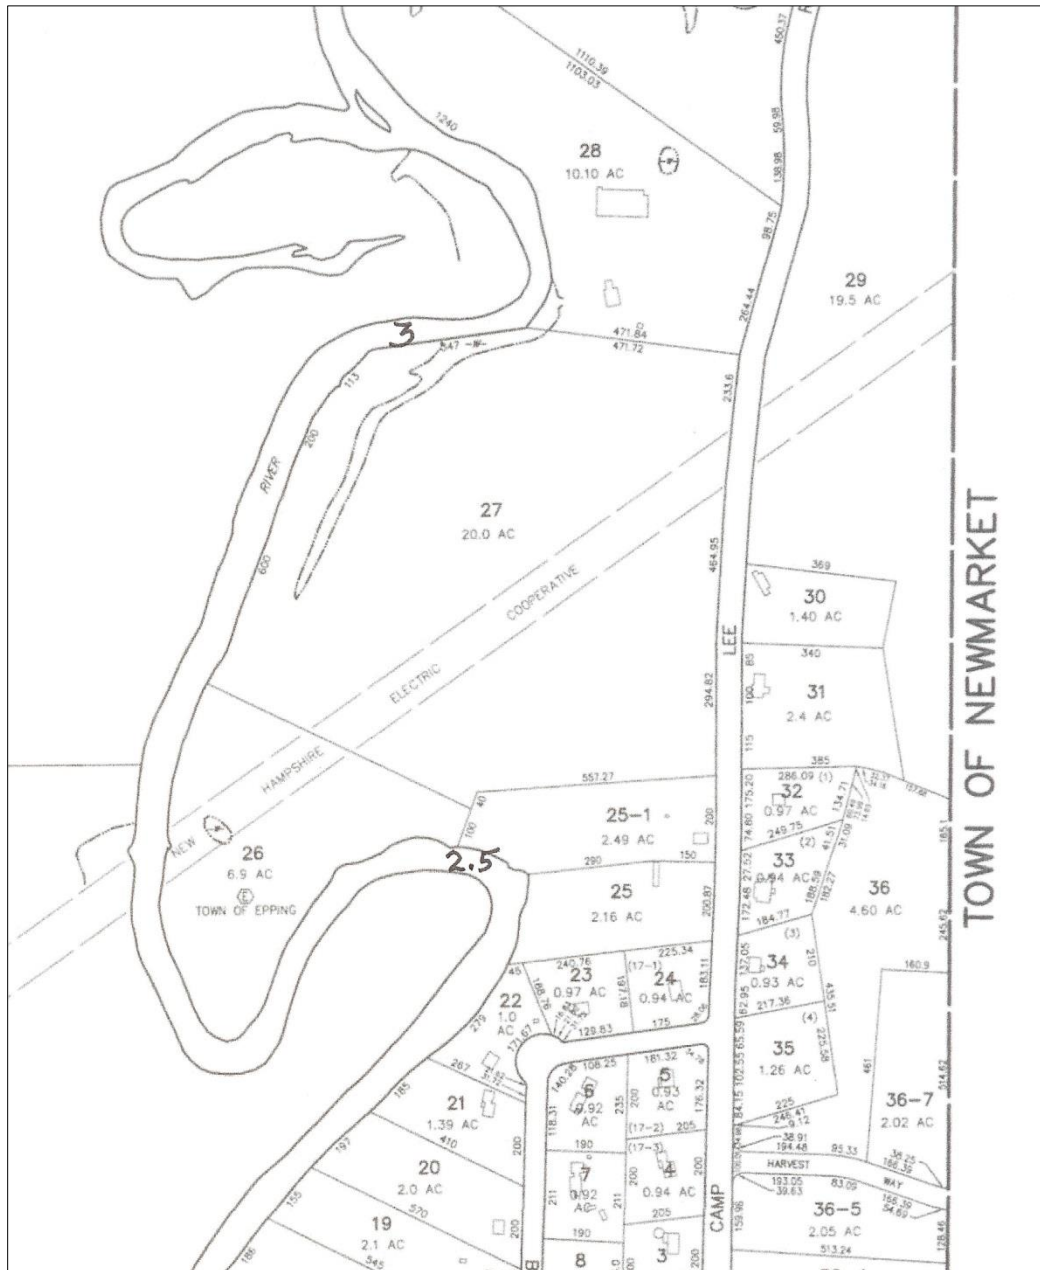
Blockage Site #	Map #	Lot #	Acres	Side of River	Landowner
2.5	11	17		West	Roger Mathes, 110 Raymond Road, Deerfield
2.5	12	25	2.16	East	Scott Kukesh, 56 Camp Lee Road, Epping
2.5	12	25-1	2.49	East	Deborah McConnell, 58 Camp Lee Road, Epping
3	11	16		West	Jeremy & James Thayer, POBox 510, Newcastle
3	12	27	20	East	Melvin & Patricia Jenkins, 80 Camp Lee Road, Epping

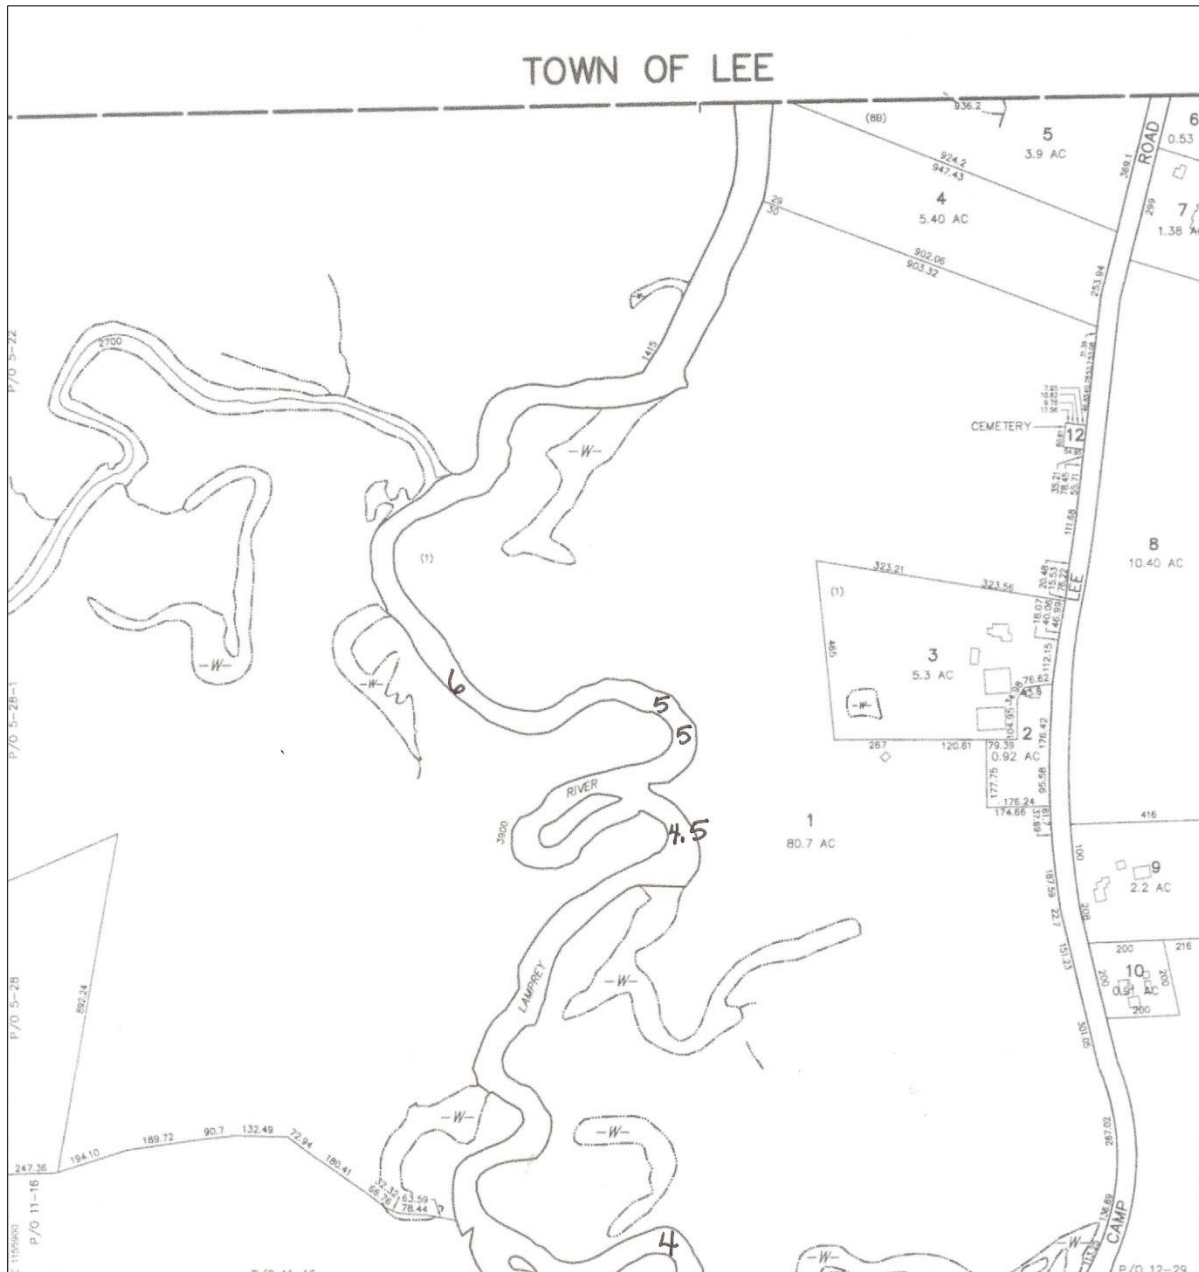
Blockage Site #	Map #	Lot #	Acres	Side of River	Landowner
4	6	1	80.7	East	Linda Clarke, 134 Camp Lee Road, Epping
4.5	6	1	80.7	East	Linda Clarke, 134 Camp Lee Road, Epping
5	6	1	80.7	East	Linda Clarke, 134 Camp Lee Road, Epping
6	5	28-1		West	SELT, Exeter
6	6	1	80.7	East	Linda Clarke, 134 Camp Lee Road, Epping
